Technical Report RFMR-CS-42
February 1994

Overlays on Horizontal Concrete Surfaces: Case Histories

by *Roy L. Campbell, Sr.*
Structures Laboratory

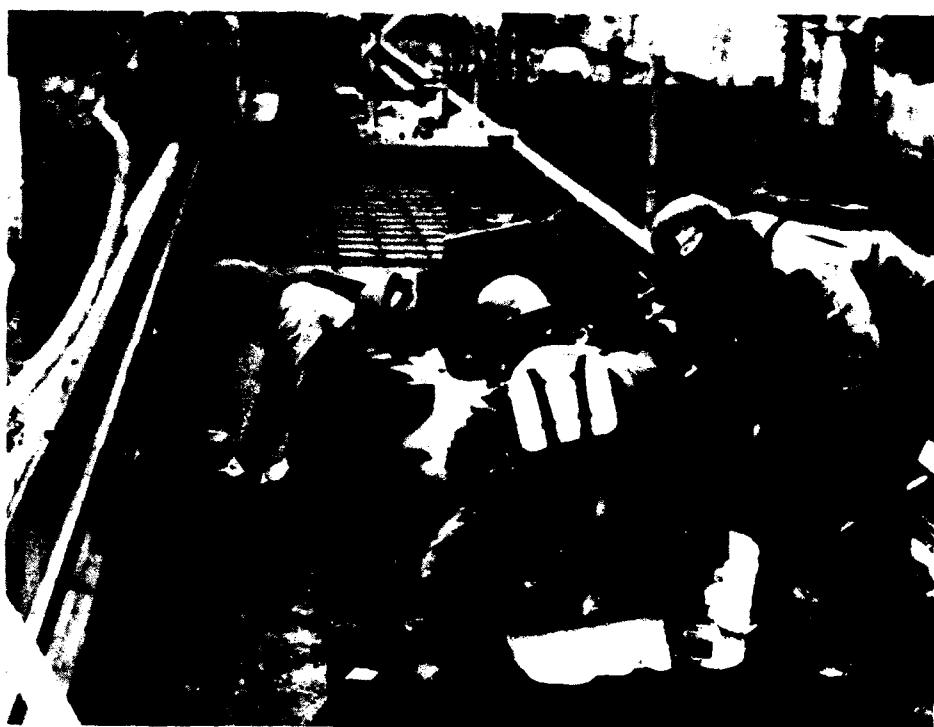
Figure 40. Bond breaker being installed, Dashields Locks, 1988

- b. In most areas, a bond breaker consisting of two layers of 15-lb (8.9-kg), ASTM D 226, Type I (ASTM 1988h), asphalt-saturated felt was placed on top of the in situ concrete prior to overlaying (Figure 40).
- c. A total of 233 ft (71.0 m) of dummy joints were employed to control random cracking (Figure 41). The bond breaker was not applied at mooring post locations as delineated by control joints shown. The joints were formed using metal strips to produce 1/4-in. (6-mm) wide grooves.

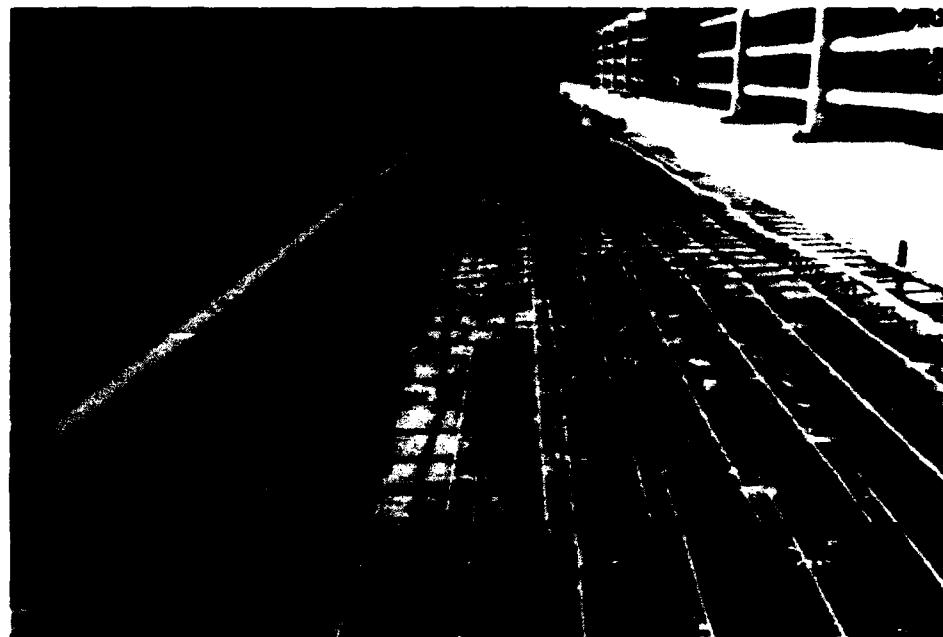
Figure 44. Bond breaker in place for unbonded overlay, Mahoning Creek Dam Roadway, 1987

A 1/16-in. (2-mm) thick, asphalt-modified urethane membrane was used as a bond breaker (Figure 44). The membrane was cured for 24 hr prior to placing the concrete.
